# Croydon Station Easy Access Upgrade Project

## Statement of Heritage Impact

Client: Transport for New South Wales

29-Oct-2015

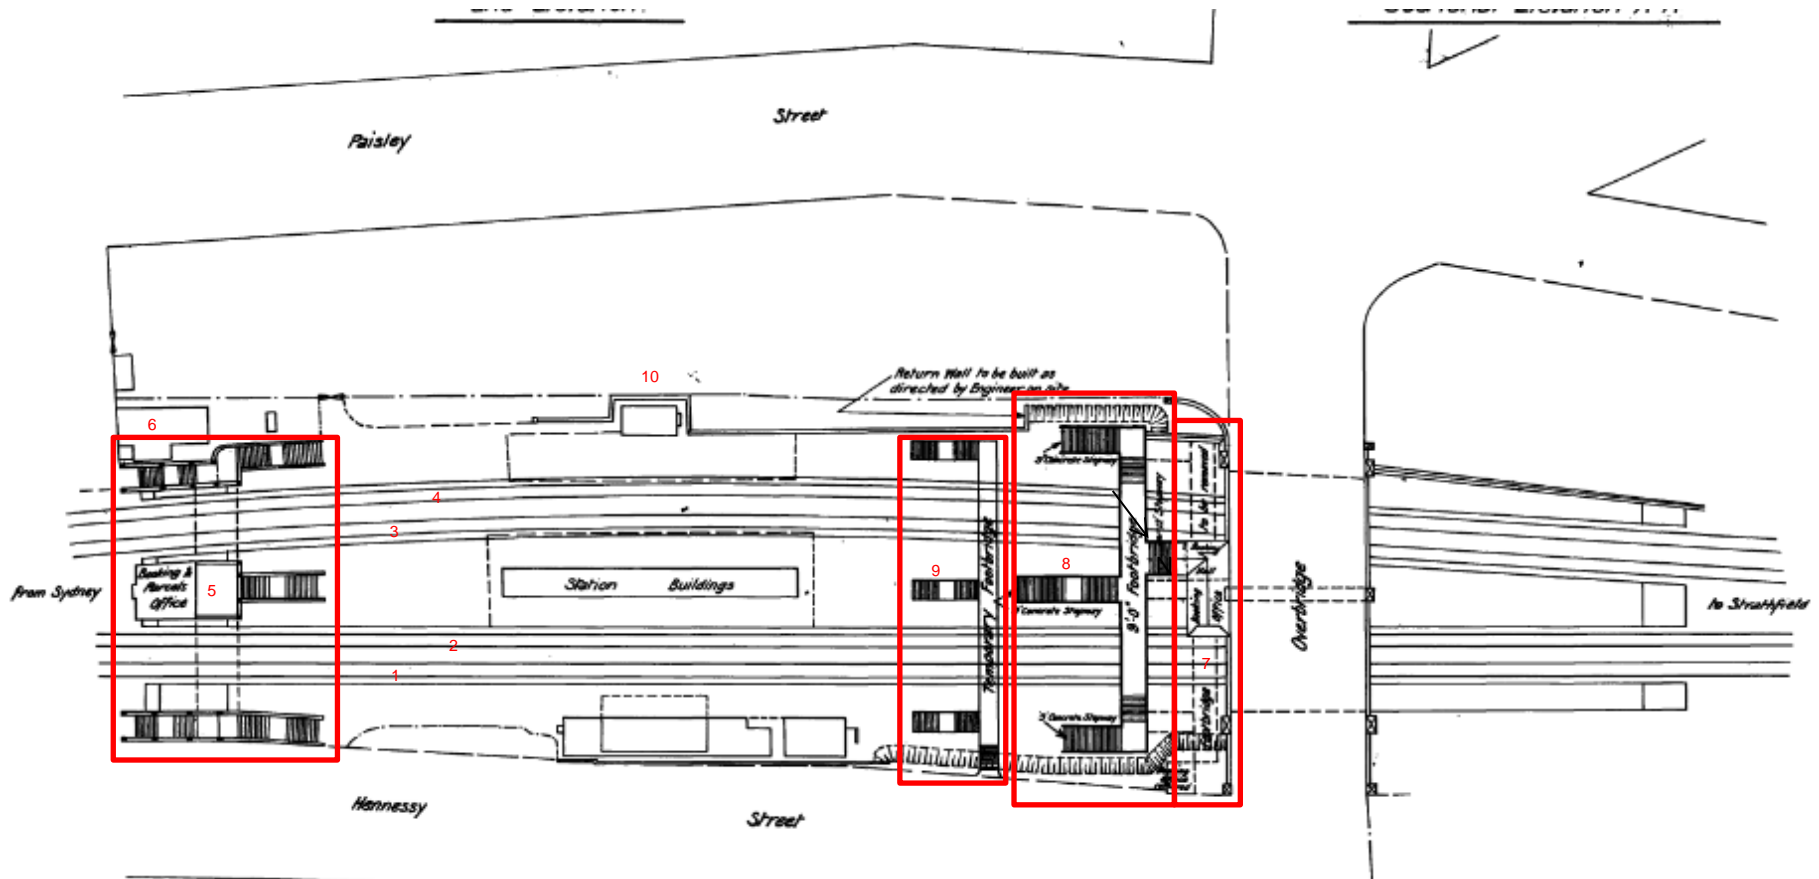
Figure 6 Arrangement of the Croydon Railway Station proposed in 1921. Source: Sydney Trains Plan Room No. CV0054658

- 1. Original Up track, now through track with no platform (1855, track only, 1870s platform building)
- 2. Original Down track, now platform 1
- 3. 1892 quadruplication, now platform 2
- 4. 1892 quadruplication, now platform 3
- 5. Subway, associated stairs and bookings and parcels office (now demolished)
- 6. pre-1890 post office
- 7. c. 1890 footbridge and booking office "to be removed"
- 8. Proposed footbridge and overhead booking office. Constructed 1922/23
- 9. Temporary footbridge of unknown date/longevity
- 10. Future location of platforms 1 and 2 following 1926/27 sextuplication

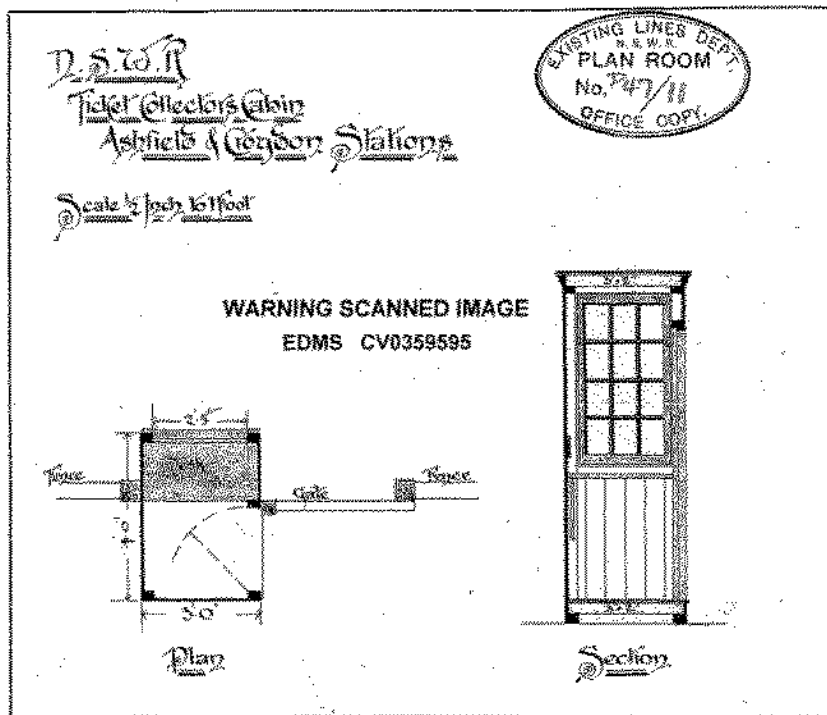
Figure 7 NSW Ticket Collectors Cabin. Ashfield and Croydon Stations. Source: Sydney Trains Plan Room EDMS CV0359595/

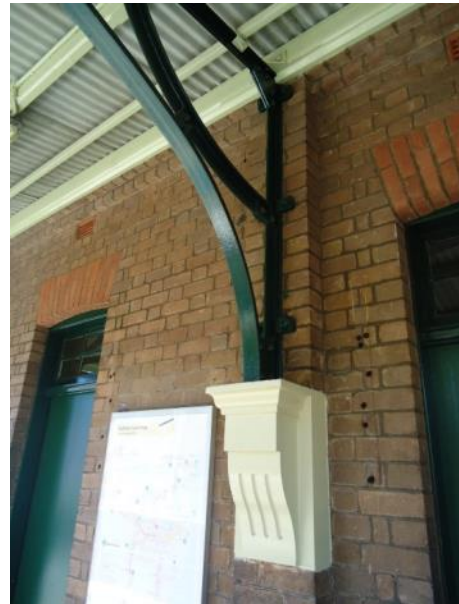
Plate 12 Platform Building 3/4 – detail of concrete corbel and metal bracket for awning.

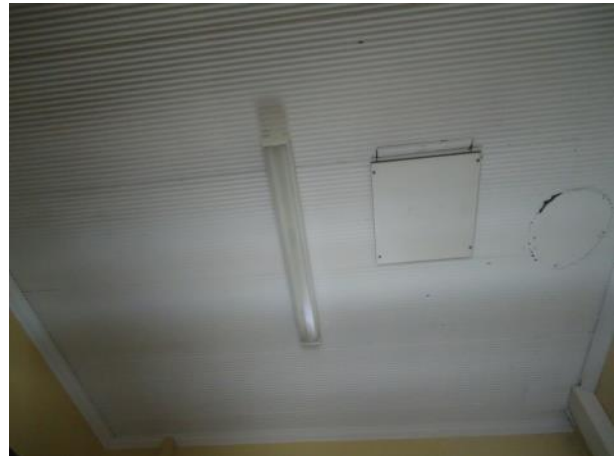
**Plate 14** Platform Building 3/4 – ceiling of store room showing modifications to mini orb corrugated iron.

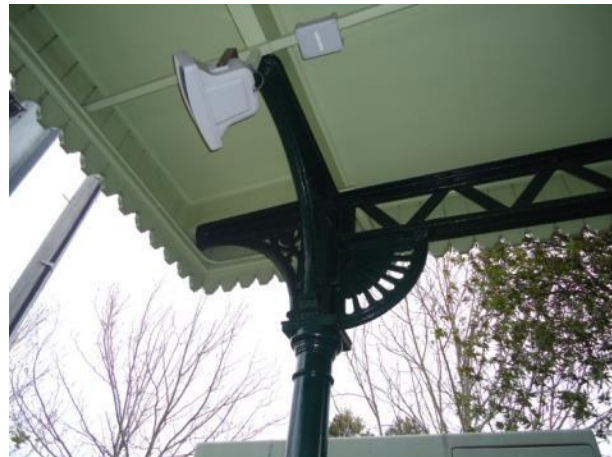
**Plate 22** Platform Building 5 – detailing of cast iron work and timber curtain fascia.

The building is attached to a canopy on the same trajectory as the building’s skillion roof (Plate 21). The canopy is supported on iron posts cast by a local Clyde company with decorative fan and scroll work detailing on the upper brackets. The ceiling is lined with plasterboard and edged with timber curtain board fascia (Plate 22).

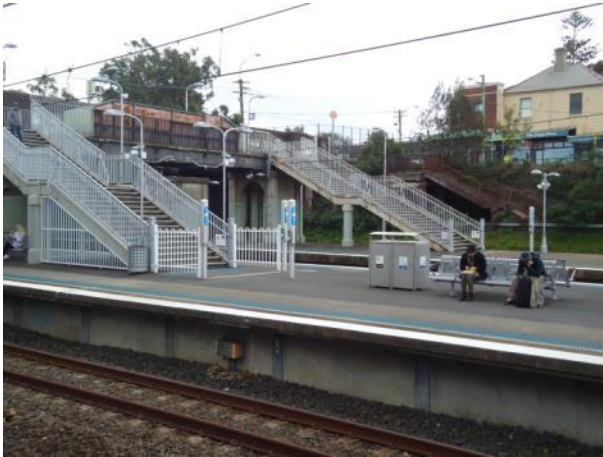
**Plate 25** Footbridge showing arrangement of stairs 1, 2 and 3. View north from platform 5.

The footbridge can be divided into two parts: the western portion, consisting of TR 1, 3 and 2A together with stairs 2, 3 and 4 (Plate 25, Plate 26, Plate 27), which is still in active use; and the eastern portion, being TR 1A, 1B and 2B and stair 1 that are no longer in active use (Plate 28, Plate 29). The use of these elements has been disabled through the removal of the span between TR 1A and 2A in 1995 and the earlier demolition of a previous overhead booking office and unpaid passenger concourse supported by TR 2B and 1B. The historical evolution of the footbridge has been more fully discussed in Section 3.0. Trestle 1B consists of a single arch, rather than the four columned trestles represented by the other trestles. As such, it lacks cross-bracing and in addition exhibits significant spalling (Plate 28).

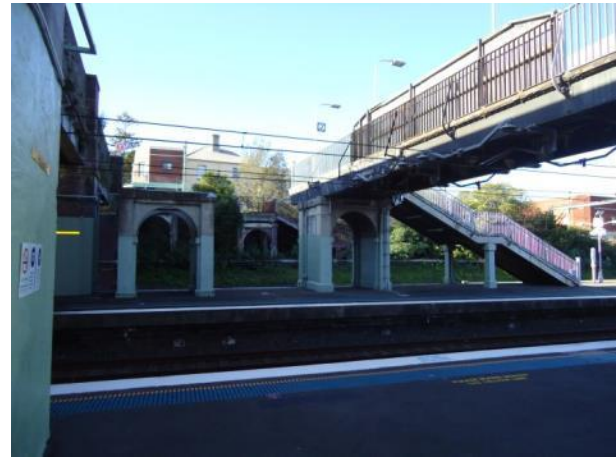
**Plate 26** Footbridge span across track 4 and 5 and trestles 2A and 2B on platform 3/4.

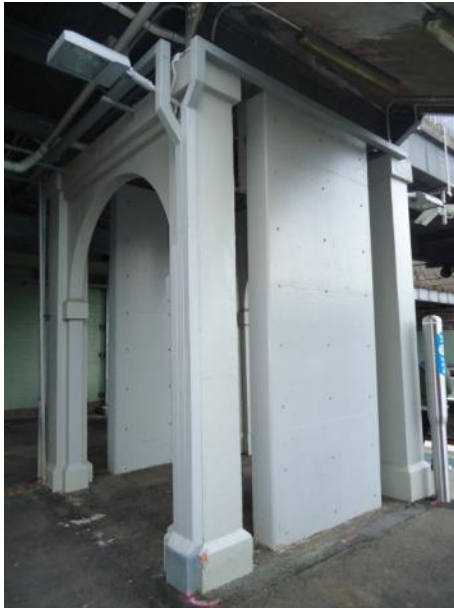
**Plate 27** Trestle 4 on platform 5 showing comparative condition. Note insertion of concrete pier for 1995 overhead booking office. View north.

The structural assessment of the footbridge prepared by Mott MacDonald (Mott MacDonald Australia, 2014a) noted that the trestles vary in their condition, with TR 4 under the overhead booking office being in reasonably good condition, probably having undergone conservation when the present overhead booking office was constructed in 1995. The concrete columns supporting the 1995 overhead booking office have been inserted within the existing trestle (Plate 27). Trestles 2A, 2B and 3 are in visibly poor condition with concrete spalling and rusted exposed reinforced steel sections (Plate 34). Trestles 1A and 1B appear in worse condition, with larger sections having come away as a result of spalling and further exposed reinforced steel sections (Plate 28, Plate 29). The initial report noted that the condition of the footbridge was potentially indicative of problematic concrete chemistry. Mott MacDonald provide the following description of what may occur over time:

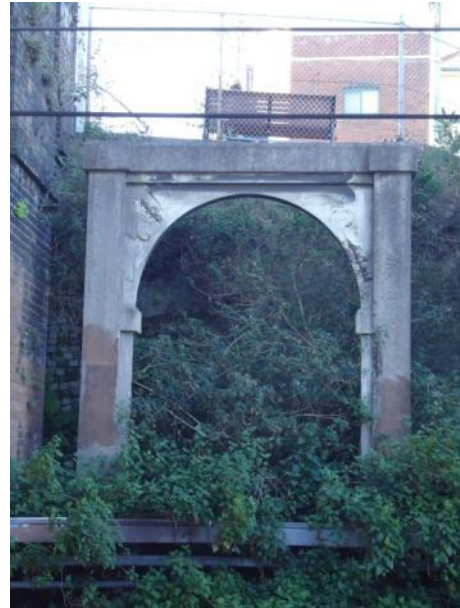
**Plate 28** Trestle 1B showing extensive spalling and lack of cross bracing.

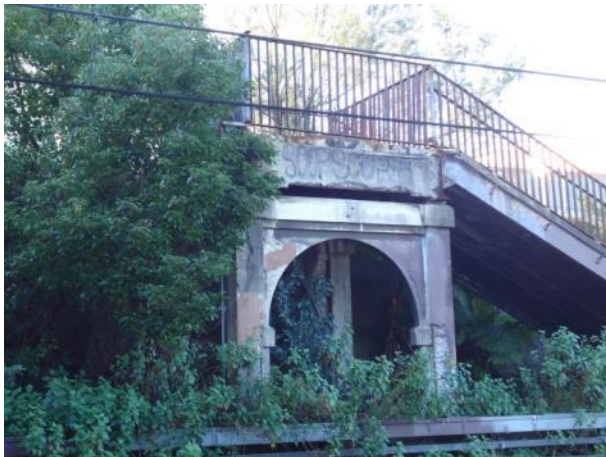
**Plate 29** Trestle 1A and stair 1. Note extensive spalling and deteriorated steel superstructure members. View north east.

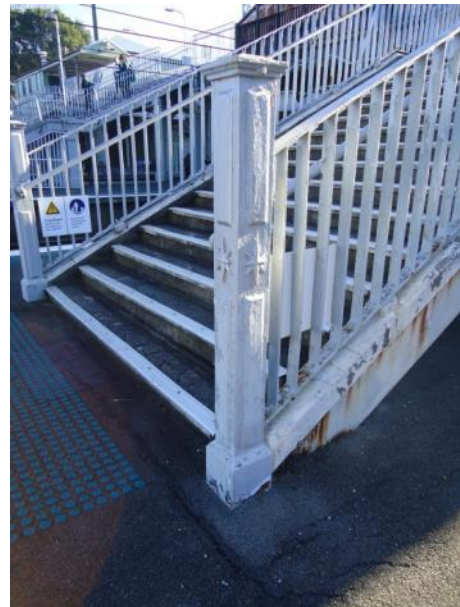
**Plate 30** Stair 3 showing original newel post and concrete stepway.

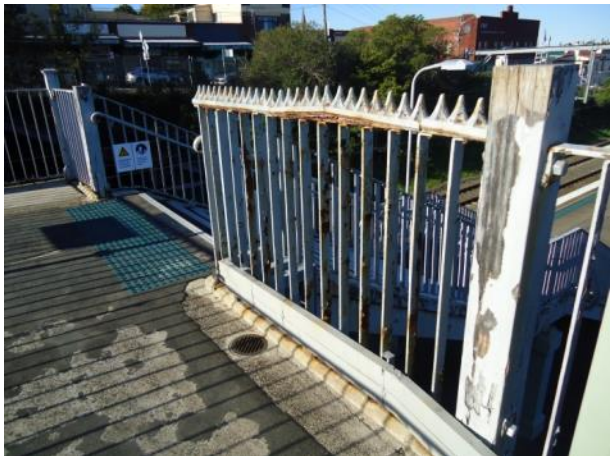
**Plate 31** Original balustrade cast iron spiked capping over platform 2 (c.1923).

The stairs are supported on concrete piers with steel beams and stringers, the steps are of reinforced concrete. The balustrades on the footbridge and stairs are a mixture of timber intermediate posts with vertical steel railings. Some original sections remain, including the cast iron newel posts at the bottom of stair 2, 3 and 4 (c.1923) (Plate 30), together with the safety balustrades and guards over tracks 2 and 3 (c.1926) and a small section of original cast iron spiked capping over platform 2 (c.1923) (Hyder Consulting, 2015:3).

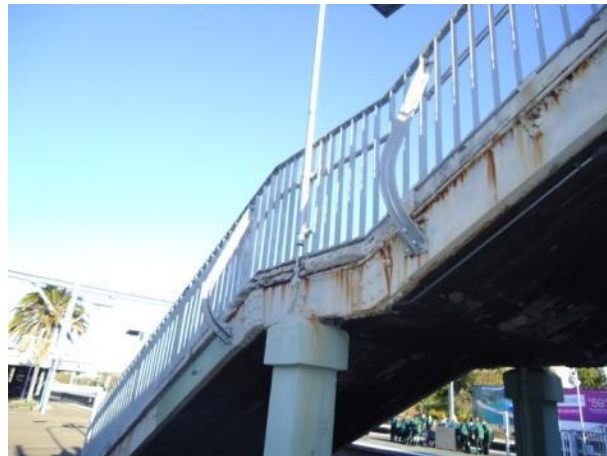
**Plate 32** Stairway steel beams and balustrades on stair 3 showing general condition and form. View south.

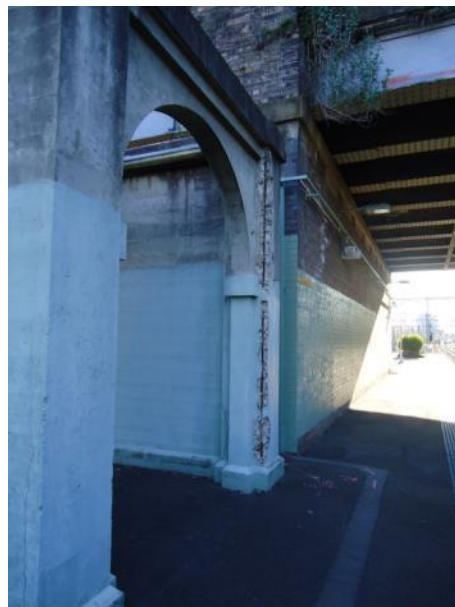
**Plate 34** Detail of trestle 2A showing reinforced steel exposed for the height of the member.

*Concrete provides an alkaline environment which protects the reinforcement from corroding. Over time by reacting with carbon dioxide in the air, the concrete becomes more acidic. This process is known as carbonation. In dense, sound concrete this carbonation is limited to near [the] surface (i.e. less than 10mm in depth). The problem arises when carbonation reaches to the depth of the reinforcement. When this happens there is no alkaline protective environment and the reinforcement begins to corrode. The rust build up is an expansive reaction and spalls the concrete.*

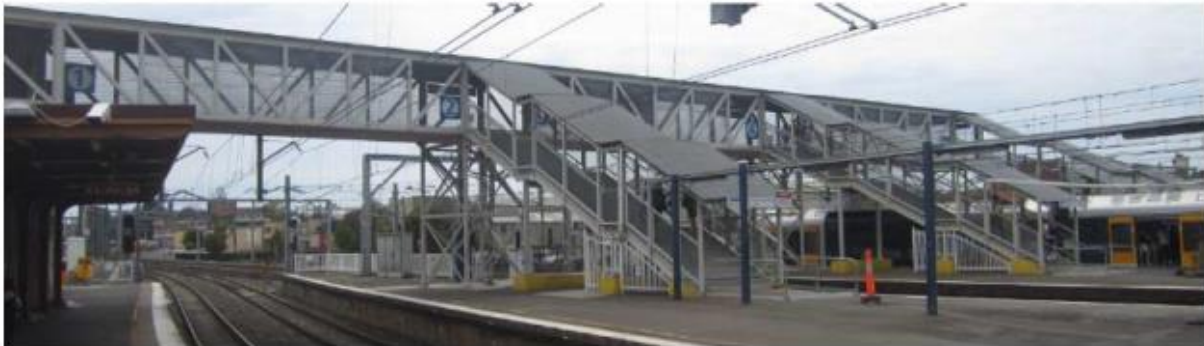
**Plate 35** Example of a temporary footbridge used during the Sydenham Station upgrade.

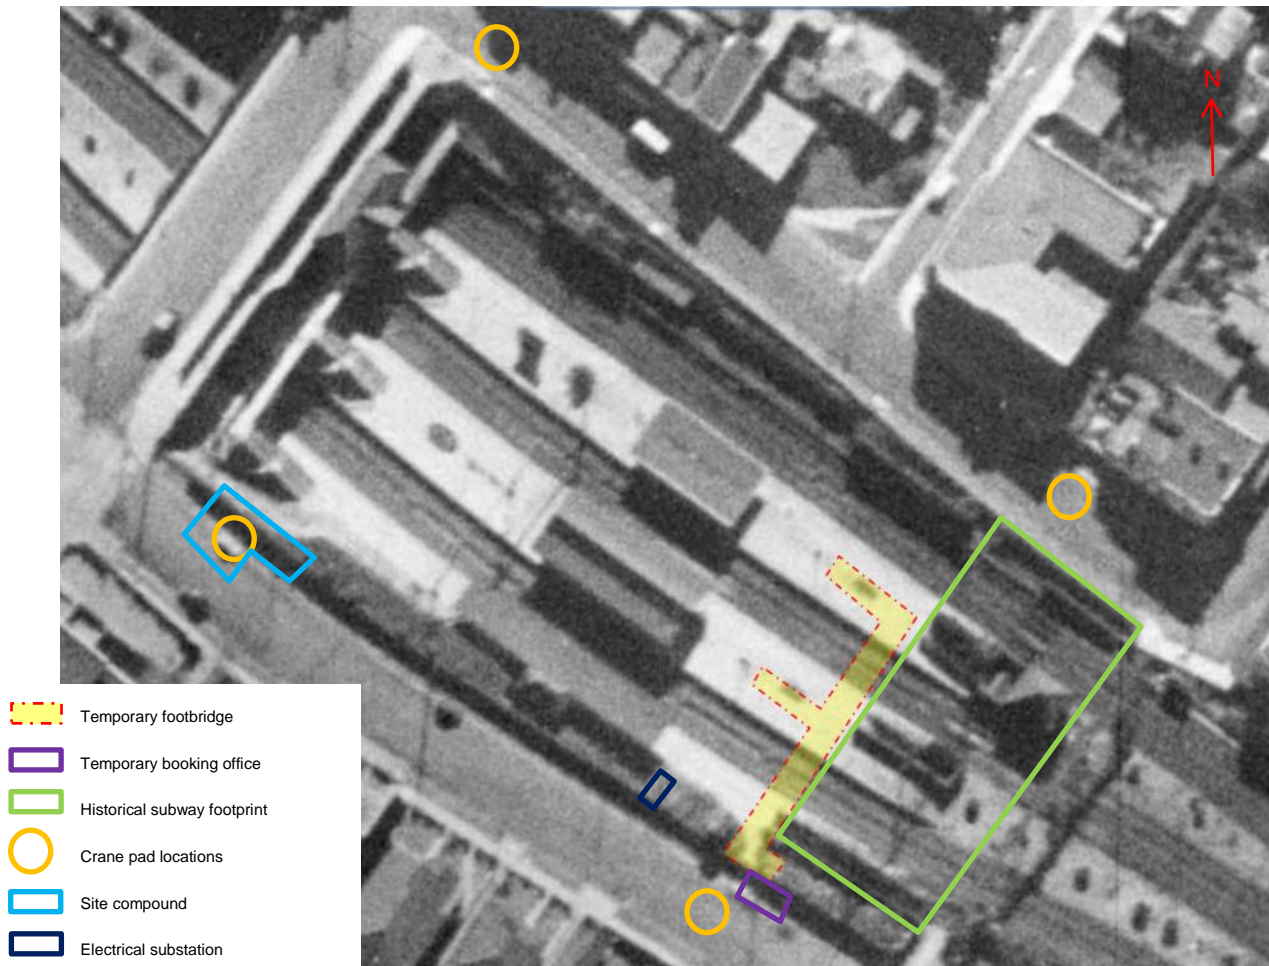
**Figure 9** Overlay of approximate location of proposed temporary works on 1943 aerial. (Source: NSW Property and Information)

The proposed location of the temporary crane pads can be seen in relation to the historic arrangement of the station in Figure 9. The pads are located in areas that have historically been road reserve, with no structures or features being identified prior to the construction of the road. It is not anticipated that these pads will impact on archaeological deposits or relics. Similarly, the site compound is located in an area that was formerly part of Paisley Road. This area has been made a no through road more recently and is paved and landscaped, but it is not anticipated that the compound will impact on archaeological features.

The location of the proposed electrical substation is shown on Figure 11 (refer to Drawing TAP-C3897-CD-MA-3808.B for detail) and on the historical 1943 aerial in Figure 9, indicating that the location is unlikely to impact on archaeological relics or deposits. In any event, the substation is to be pad mounted and will require minimal excavation. The existing substation, located just to the west of the proposed location, will be removed to reduce visual clutter.

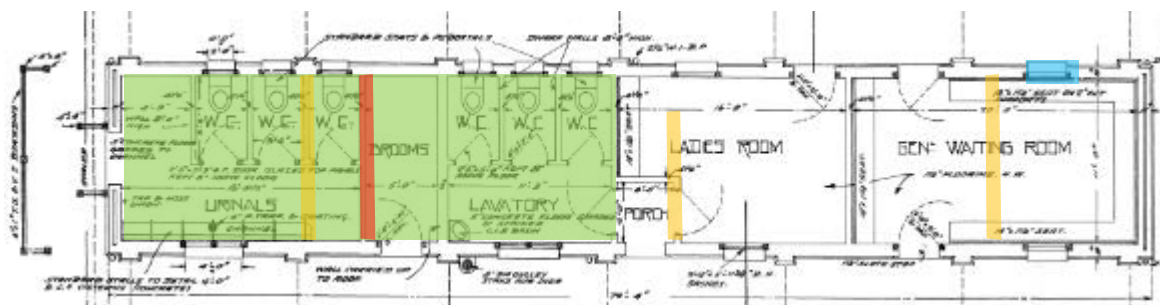
**Figure 10 Platform 3/4 Station Building plans, 1926, showing the building as built. Areas of existing modification highlighted. Modified from Sydney Trains Plan CV0053158**

The current communications room contains one rack and does not have sufficient space to allow for the insertion of a further two racks – three racks having been identified as the number necessary to meet the existing and future needs of the station. The interior of the Platform 3/4 station building has already been extensively modified to suite the changing needs of the station, as shown in Figure 10. The proposed establishment of the communications room proposes the removal of a weatherboard wall that has been inserted into the previous general waiting room. This wall is not original and is not of historical significance beyond demonstrating the evolving use of the platform building to meet the needs of station staff and patrons. However, the ceiling in the two rooms that formerly comprised the general waiting room consists of mini orb corrugated iron and is potentially original or very early. It has been impacted by the previous installation and removal of services (Plate 14). It is recommended that, where possible, existing openings be reused for the installation of the GPOs.
