Transport
for NSW

Putty Road, Terrys Creek

Slope Remediation

Minor works review of
environmental factors

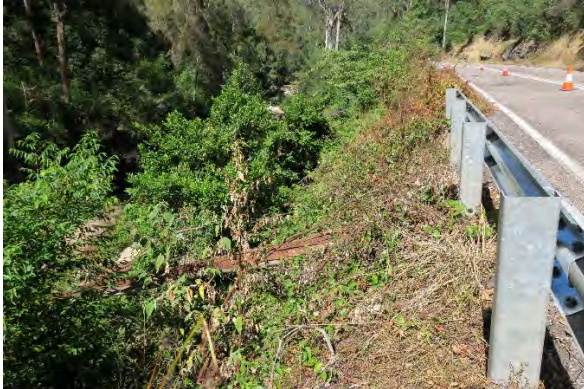
No other remains of dry stone walls were visible along the crest of the embankment. The original dry stone walls supporting the upper road embankment along the length of the road failed with the loss of shoulder to and behind the guard rail to the edge of the pavement. The dry stone walls were originally constructed within the embankment to support the upper fill materials.

Figure 9. Site 3, embankment loss and heavy vegetation along the steep embankment slope, looking south. Source: Extent Heritage, March 2023.

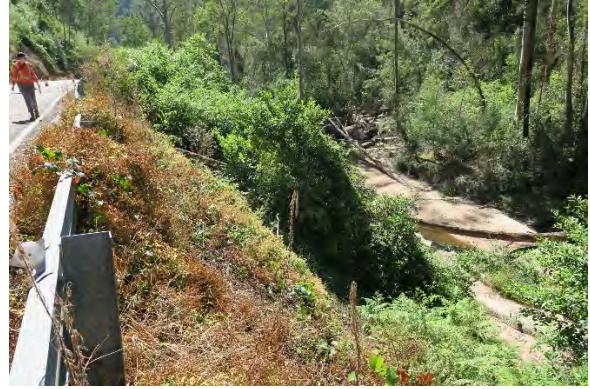
Figure 10. Site 3, embankment loss and heavy vegetation along the steep embankment slope, looking north. Source: Extent Heritage, March 2023.

Site 3 measures 135m in length and is located along TfNSW Slope 18011, north of Terrys Creek. Site 3 has been subject to extensive embankment loss and erosion, with heavy vegetation covering the steep slope towards Darkey Creek (Figure 9 to Figure 12, below).

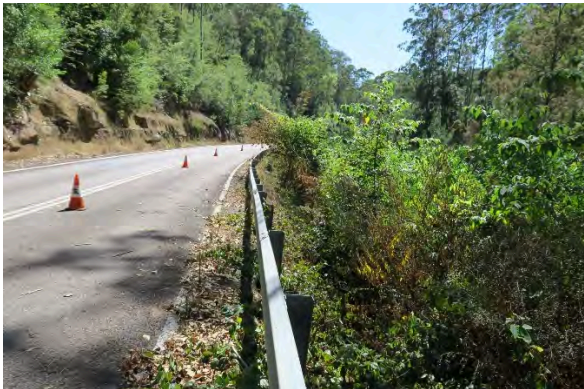
Figure 11. Site 3, embankment loss and heavy vegetation along the steep embankment slope, looking north. Source: Extent Heritage, March 2023.

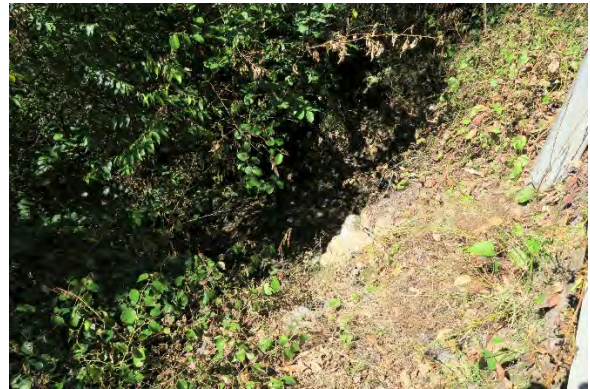
Figure 12. Site 3, eroded slope and vegetation above dry stone headwall, looking down to culvert at chainage 120m. Source: Extent Heritage, March 2023.

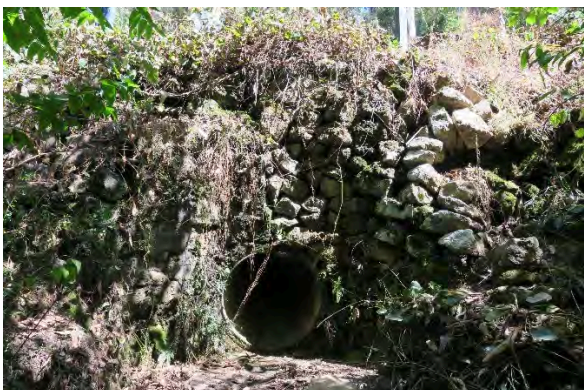
Figure 13. Site 3, culvert and dry stone headwall at chainage 120m, covered in vegetation. Source: Extent Heritage, March 2023.

The dry stone headwall associated with culvert 357107 at chainage 120m is still largely intact (Figure 13 to Figure 14, below). The dry stone wall measures approximately 2.5m in height and extends 3m in length. It comprises uncut sandstone, 10-20cm in size and interspersed with larger boulders. The upper courses of stone are in a poor condition due to effects of erosion and vegetation.

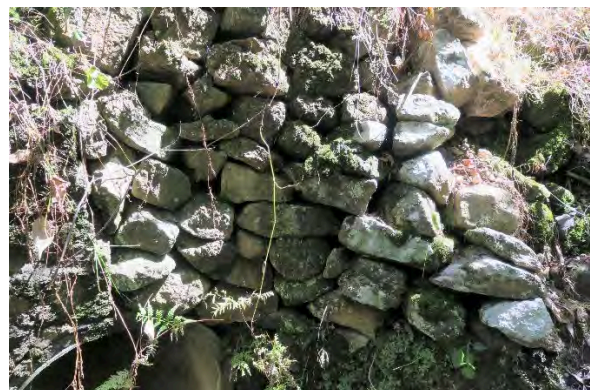
Figure 14. Site 3, detail of headwall above culvert showing dry stone construction made from irregular, uncut sandstone. Source: Extent Heritage, March 2023.

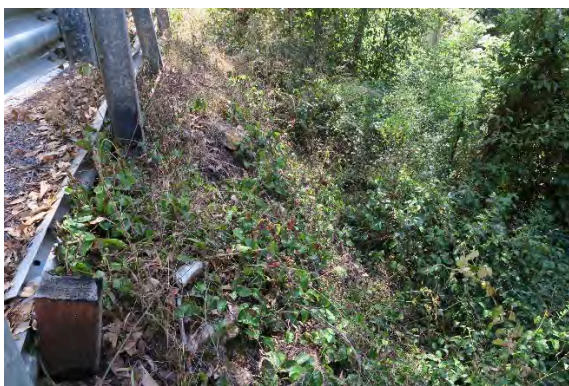
Only minor remnant dry stone walls were visible along the crest of the embankment and comprised two sandstone blocks, with no lower course visible due to vegetation (Figure 15 to Figure 17). No other remains of previously identified dry stone walls were visible. The original dry stone walls supporting the upper road embankment along the length of the road failed with the loss of shoulder to and behind the guard rail to the edge of the pavement. The dry stone walls were originally constructed within the embankment to support the upper fill materials.

Figure 15. Site 4, remnant dry stone wall along eroded embankment, covered in heavy vegetation. Source: Extent Heritage, March 2023.

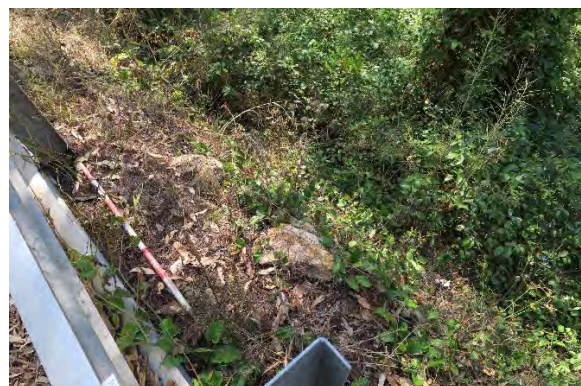
Figure 16. Site 4, detail of remnant dry stone wall on eroded embankment, covered in heavy vegetation. Source: Extent Heritage, March 2023.

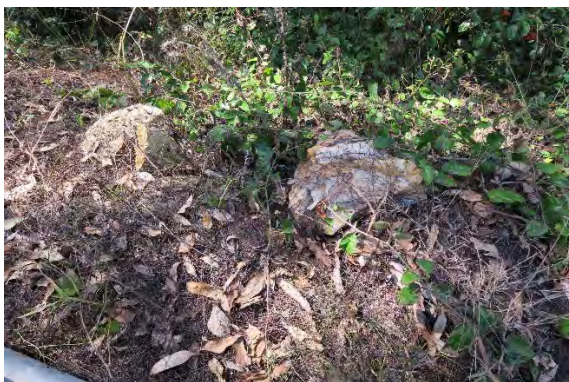
Figure 17. Site 4, detail of two uncut sandstone blocks from remnant dry stone wall, with heavy vegetation covering embankment, looking downslope towards Darkey Creek. Source: Extent Heritage, March 2023.

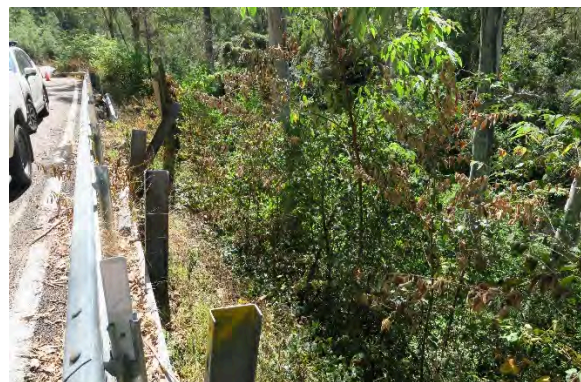
Figure 18. Site 4, embankment loss and heavy vegetation along the steep embankment slope, looking north. Source: Extent Heritage, March 2023.

Site 4 measures 60m in length and is located along TfNSW Slope 18010, north of Terrys Creek. Site 4 has been subject to extensive embankment loss and erosion, with heavy vegetation covering the steep slope towards Darkey Creek (Figure 18).

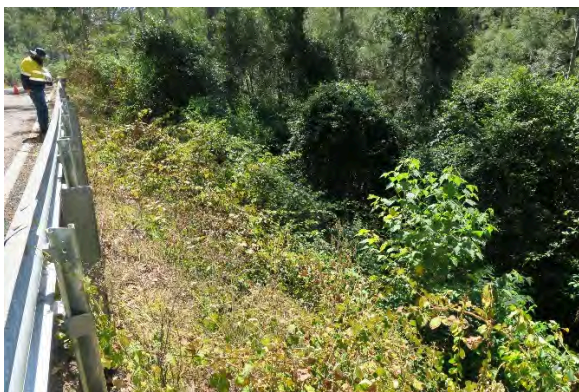
No remains of previously identified dry stone walls were visible along the crest of the embankment. The original dry stone walls supporting the upper road embankment along the length of the road failed with the loss of shoulder to and behind the guard rail to the edge of the pavement. The dry stone walls were originally constructed within the embankment to support the upper fill materials.

Figure 19. Site 5, embankment loss and heavy vegetation along the embankment slope, with a steep drop off to Darkey Creek, looking north. Source: Extent Heritage, March 2023.

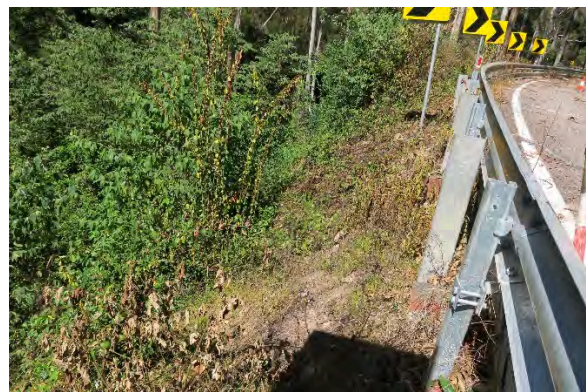
Figure 20. Site 5, embankment loss and heavy vegetation along the embankment slope, with a steep drop off to Darkey Creek, looking south. Source: Extent Heritage, March 2023.

Site 5 measures 60m in length and is located along TfNSW Slope 18010, north of Terrys Creek. Site 5 has been subject to extensive embankment loss and erosion, with heavy vegetation covering the steep slope towards Darkey Creek (Figure 19 to Figure 20).

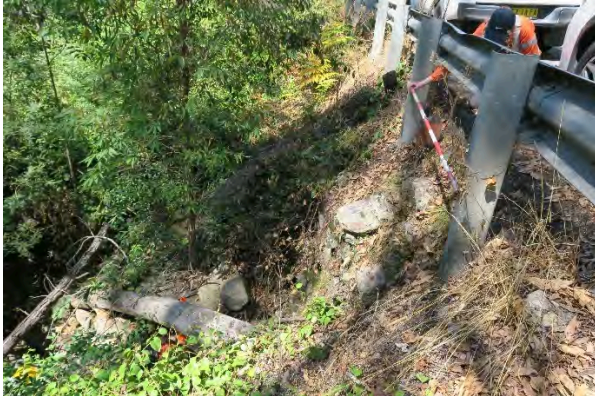
No other remains of dry stone walls were visible along the crest of the embankment. The original dry stone walls supporting the upper road embankment along the length of the road failed with the loss of shoulder to and behind the guard rail to the edge of the pavement. The dry stone walls were originally constructed within the embankment to support the upper fill materials.

Figure 21. Site 7, eroded dry stone headwall and culvert with 2m scale, looking south. Source: Extent Heritage, March 2023.

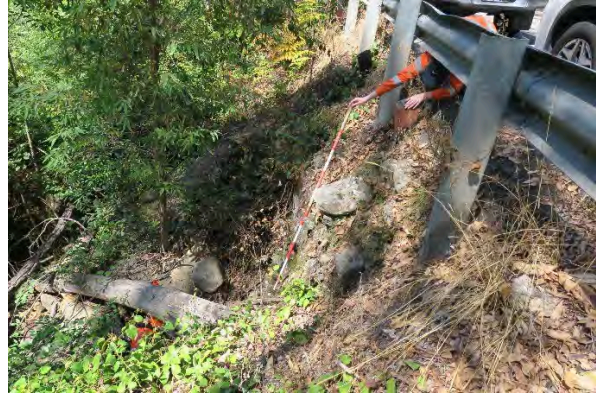
Figure 22. Site 7, eroded dry stone headwall and culvert with 2m scale, looking south. Source: Extent Heritage, March 2023.

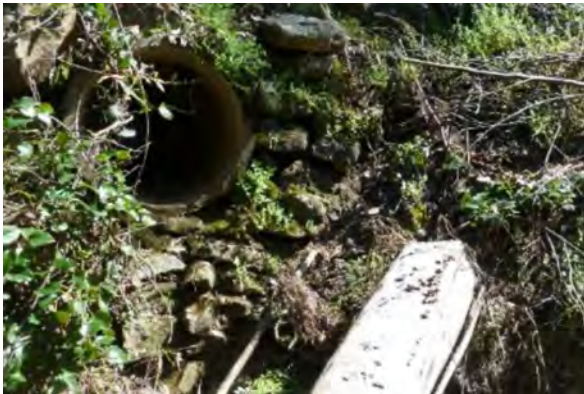
Figure 23. Site 7, detail of culvert and dry stone headwall covered in heavy vegetation. Source: Newcastle Geotech, September 2022.

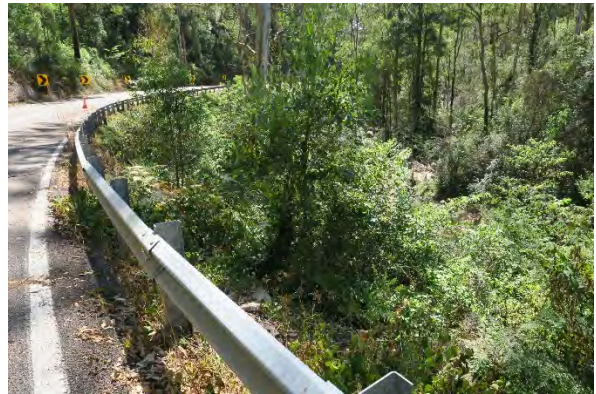
Figure 24. Site 7, loss of embankment with heavy vegetation along steep embankment slope to Darkey Creek, looking north. Source: Extent Heritage, March 2023.

Site 7 measures 80m in length and is located along TfNSW Slope 18009, north of Terrys Creek. Site 7 has been subject to extensive embankment loss and erosion, with heavy vegetation covering the steep slope towards Darkey Creek (Figure 24).

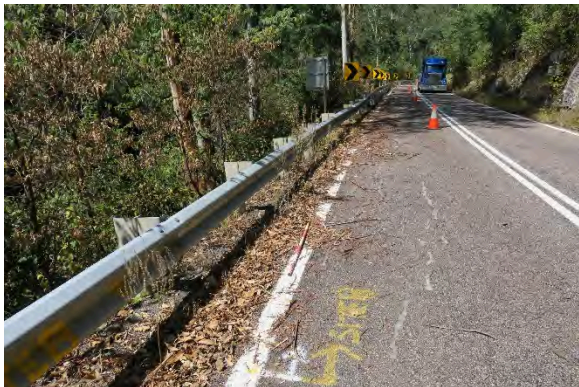
No remains of previously identified dry stone walls were visible along the crest of the embankment. The original dry stone walls supporting the upper road embankment along the length of the road failed with the loss of shoulder to and behind the guard rail to the edge of the pavement. The dry stone walls were originally constructed within the embankment to support the upper fill materials.

Figure 25. Site 8, steep slope towards Darkey Creek with embankment loss with heavy vegetation, looking south. Adjacent cutaway secured with metal netting. Source: Extent Heritage, March 2023.

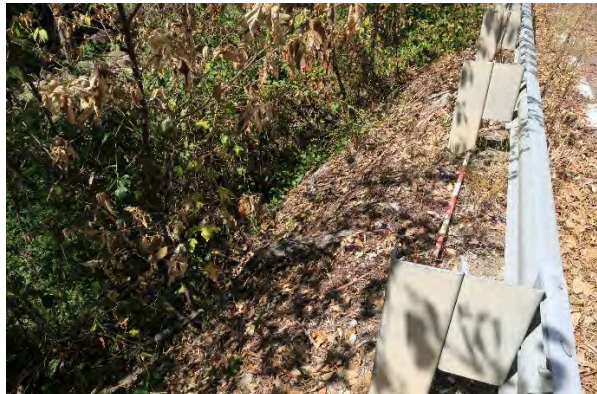
Figure 26. Site 8, erosion and embankment loss with heavy vegetation downslope to Darkey Creek, looking south. Source: Extent Heritage, March 2023.

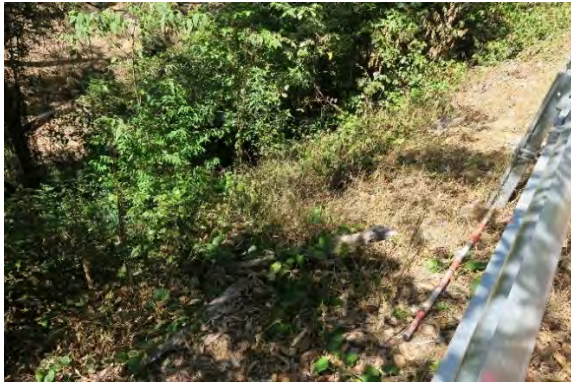
No remains of dry stone walls were visible along the crest of the embankment. The original dry stone walls supporting the upper road embankment along the length of the road failed with the loss of shoulder to and behind the guard rail to the edge of the pavement. The dry stone walls were originally constructed within the embankment to support the upper fill materials.

Figure 27. Site 9, embankment loss with erosion and heavy vegetation, looking south. Source: Extent Heritage, March 2023.

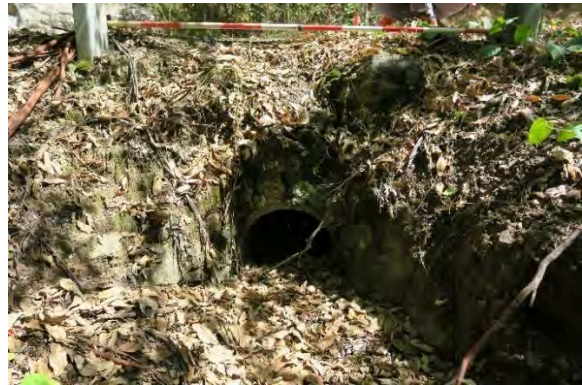
Figure 28. Site 9, culvert 357111 and dry stone headwall with evidence of concrete additions. Source: Extent Heritage, March 2023.

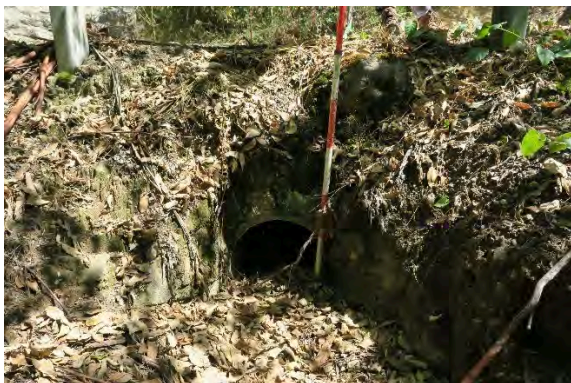
Figure 29. Site 9, culvert 357111 and dry stone headwall with evidence of concrete additions. Source: Extent Heritage, March 2023.

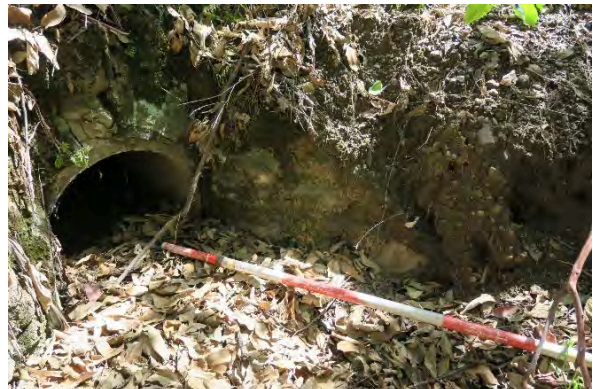
Figure 30. Site 9, detail of culvert 357111 and dry stone headwall with evidence of concrete additions. Source: Extent Heritage, March 2023.

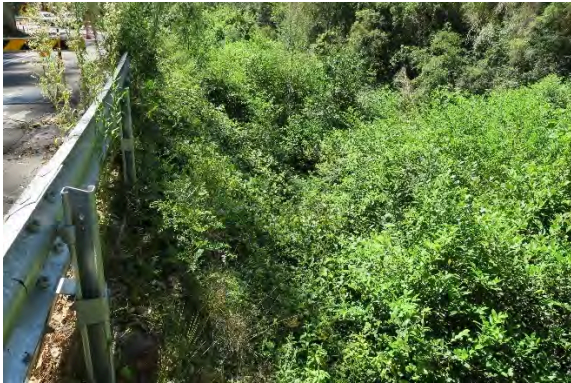
No remains of previously identified dry stone walls were visible along the crest of the embankment. The original dry stone walls supporting the upper road embankment along the length of the road failed with the loss of shoulder to and behind the guard rail to the edge of the pavement. The dry stone walls were originally constructed within the embankment to support the upper fill materials.

Figure 31. Site 10, embankment loss and heavy vegetation on steep embankment slope towards Darkey Creek, looking north. Source: Extent Heritage, March 2023.

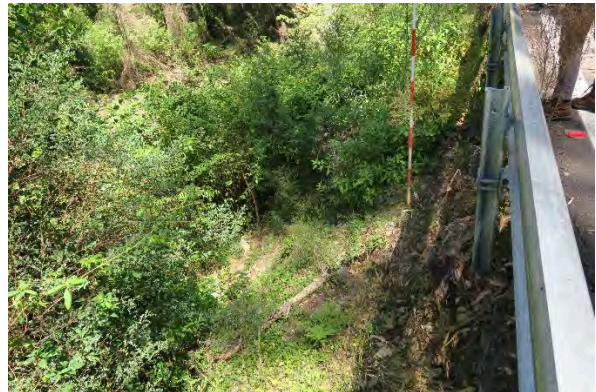
Figure 32. Site 10, embankment loss and heavy vegetation, timber post visible, looking south. Source: Extent Heritage, March 2023.

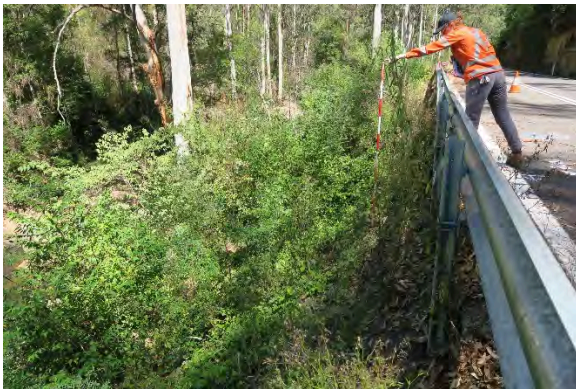
Figure 33. Site 10, embankment loss and heavy vegetation on steep embankment slope towards Darkey Creek, looking south. Source: Extent Heritage, March 2023.

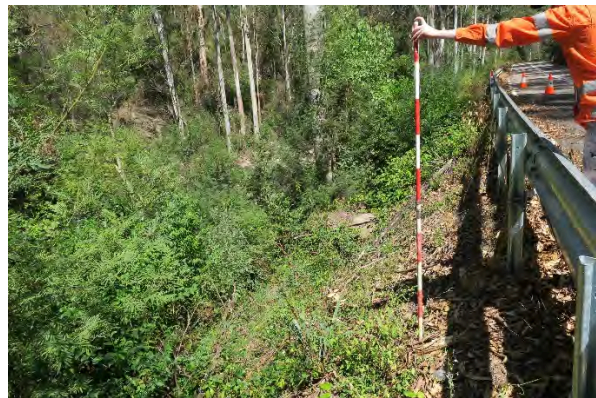
Figure 34. Site 10, embankment loss and heavy vegetation on steep embankment slope towards Darkey Creek, looking south. Source: Extent Heritage, March 2023.

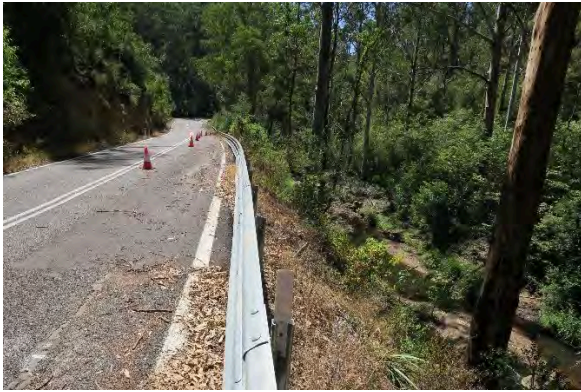
No remains of previously identified dry stone walls were visible along the crest of the embankment. The original dry stone walls supporting the upper road embankment along the length of the road failed with the loss of shoulder to and behind the guard rail to the edge of the pavement. The dry stone walls were originally constructed within the embankment to support the upper fill materials.

Figure 35. Site 11, erosion and embankment loss downslope towards Darkey Creek, looking north. Source: Extent Heritage, March 2023.

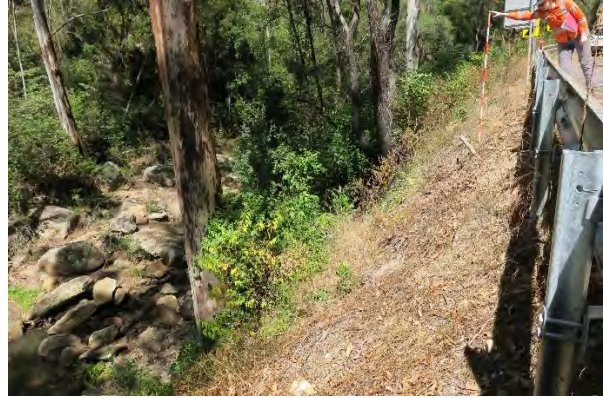
Figure 36. Site 11, erosion and embankment loss downslope with some vegetation towards Darkey Creek, looking south. Source: Extent Heritage, March 2023.

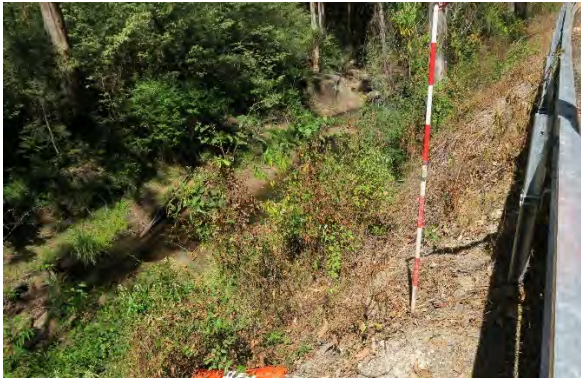
No other remains of dry stone walls were visible along the crest of the embankment. The original dry stone walls supporting the upper road embankment along the length of the road failed with the loss of shoulder to and behind the guard rail to the edge of the pavement. The dry stone walls were originally constructed within the embankment to support the upper fill materials.

Figure 37. Site 13, erosion and embankment loss downslope towards Darkey Creek, looking slope. Source: Extent Heritage, March 2023.

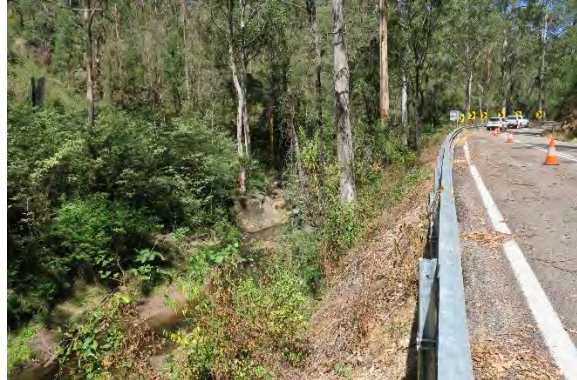
Figure 38. Site 13, erosion and embankment loss downslope towards Darkey Creek, looking slope. Source: Extent Heritage, March 2023.

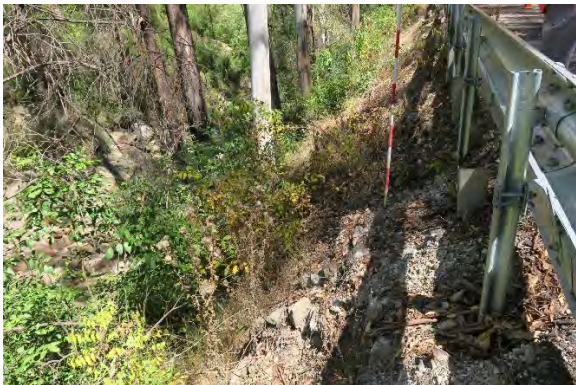
Figure 39. Site 13, remnant dry stone walls at chainage 20m, erosion along embankment, looking south. Source: Extent Heritage, March 2023.

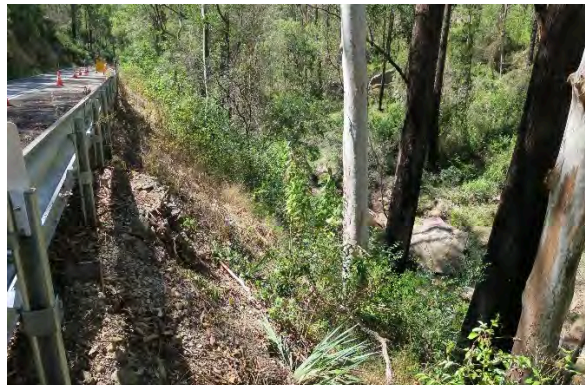
Figure 40. Site 13, intact dry stone wall adjacent to culvert at chainage 30-35m, erosion along embankment, looking north. Source: Extent Heritage, March 2023.

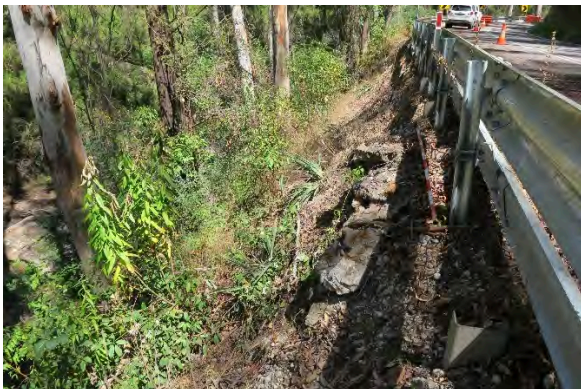
Figure 41. Site 13, intact dry stone wall adjacent to culvert at chainage 30-35m, erosion along embankment, looking south. Source: Extent Heritage, March 2023.

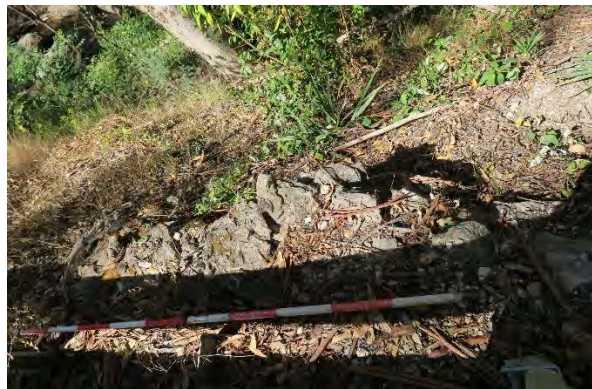
Figure 42. Site 13, intact dry stone wall adjacent to culvert at chainage 30-35m, erosion along embankment, looking east towards Darkey Creeks. Source: Extent Heritage, March 2023.

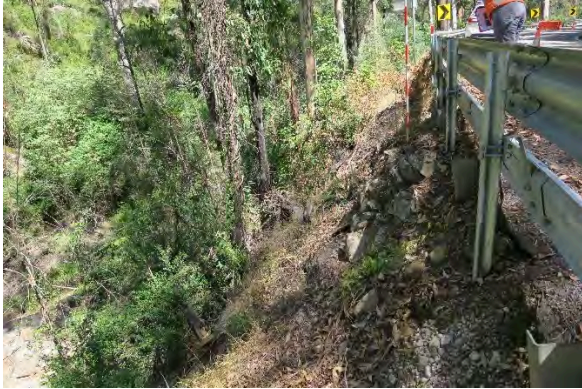
Figure 43. Site 13, dry stone wall at chainage 45-50m, erosion along embankment, looking south. Source: Extent Heritage, March 2023.

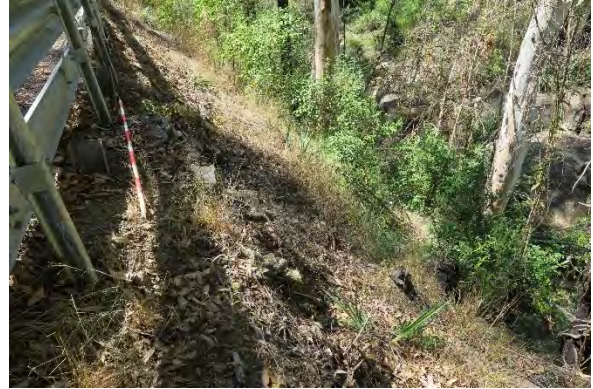
Figure 44. Site 13, dry stone wall at chainage 45-50m, erosion along embankment, looking north. Source: Extent Heritage, March 2023.

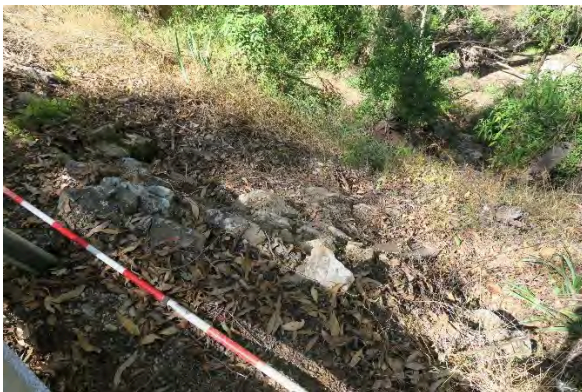
Figure 45. Site 13, dry stone wall at chainage 45-50m, erosion along embankment, looking downslope towards Darkey Creek. Source: Extent Heritage, March 2023.

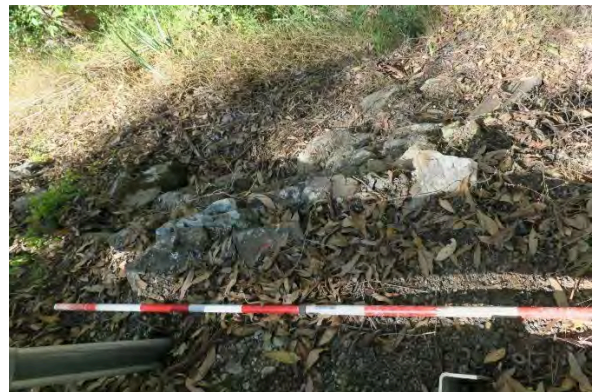
Figure 46. Site 13, detail of dry stone wall at chainage 45-50m, erosion along embankment, looking downslope towards Darkey Creek. Source: Extent Heritage, March 2023.

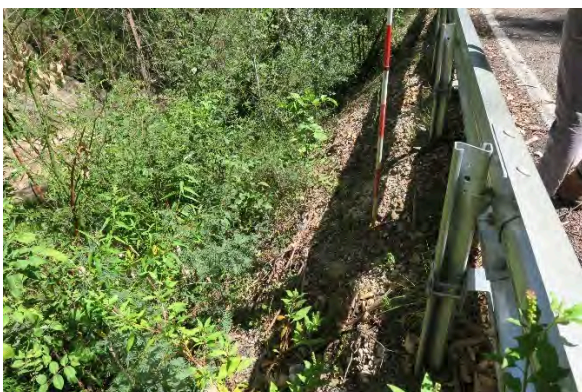
Figure 47. Site 13, embankment loss with erosion and heavy vegetation along steep embankment slope, looking south. Source: Extent Heritage, March 2023.

Site 13 measures 140m in length and is located along TfNSW Slope 18003, south of Terrys Creek. Site 13 has been subject to extensive embankment loss and erosion, with heavy vegetation covering the steep slope towards Darkey Creek, especially in the southern half of the site (Figure 37 to Figure 38, and Figure 47 to Figure 48). Three remnant sections of dry stone wall supporting the upper road embankment are still present between chainages 20 to 50m.

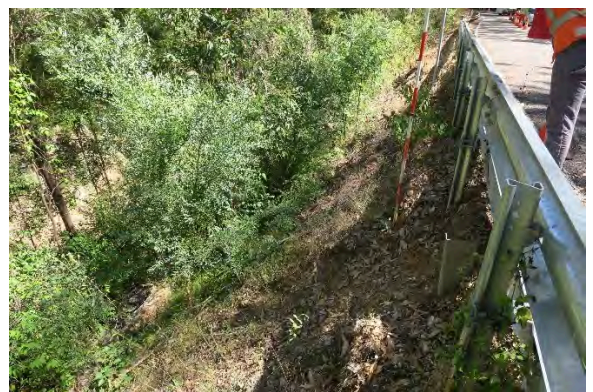
Figure 48. Site 13, embankment loss with erosion and heavy vegetation along steep embankment slope, looking south. Source: Extent Heritage, March 2023.

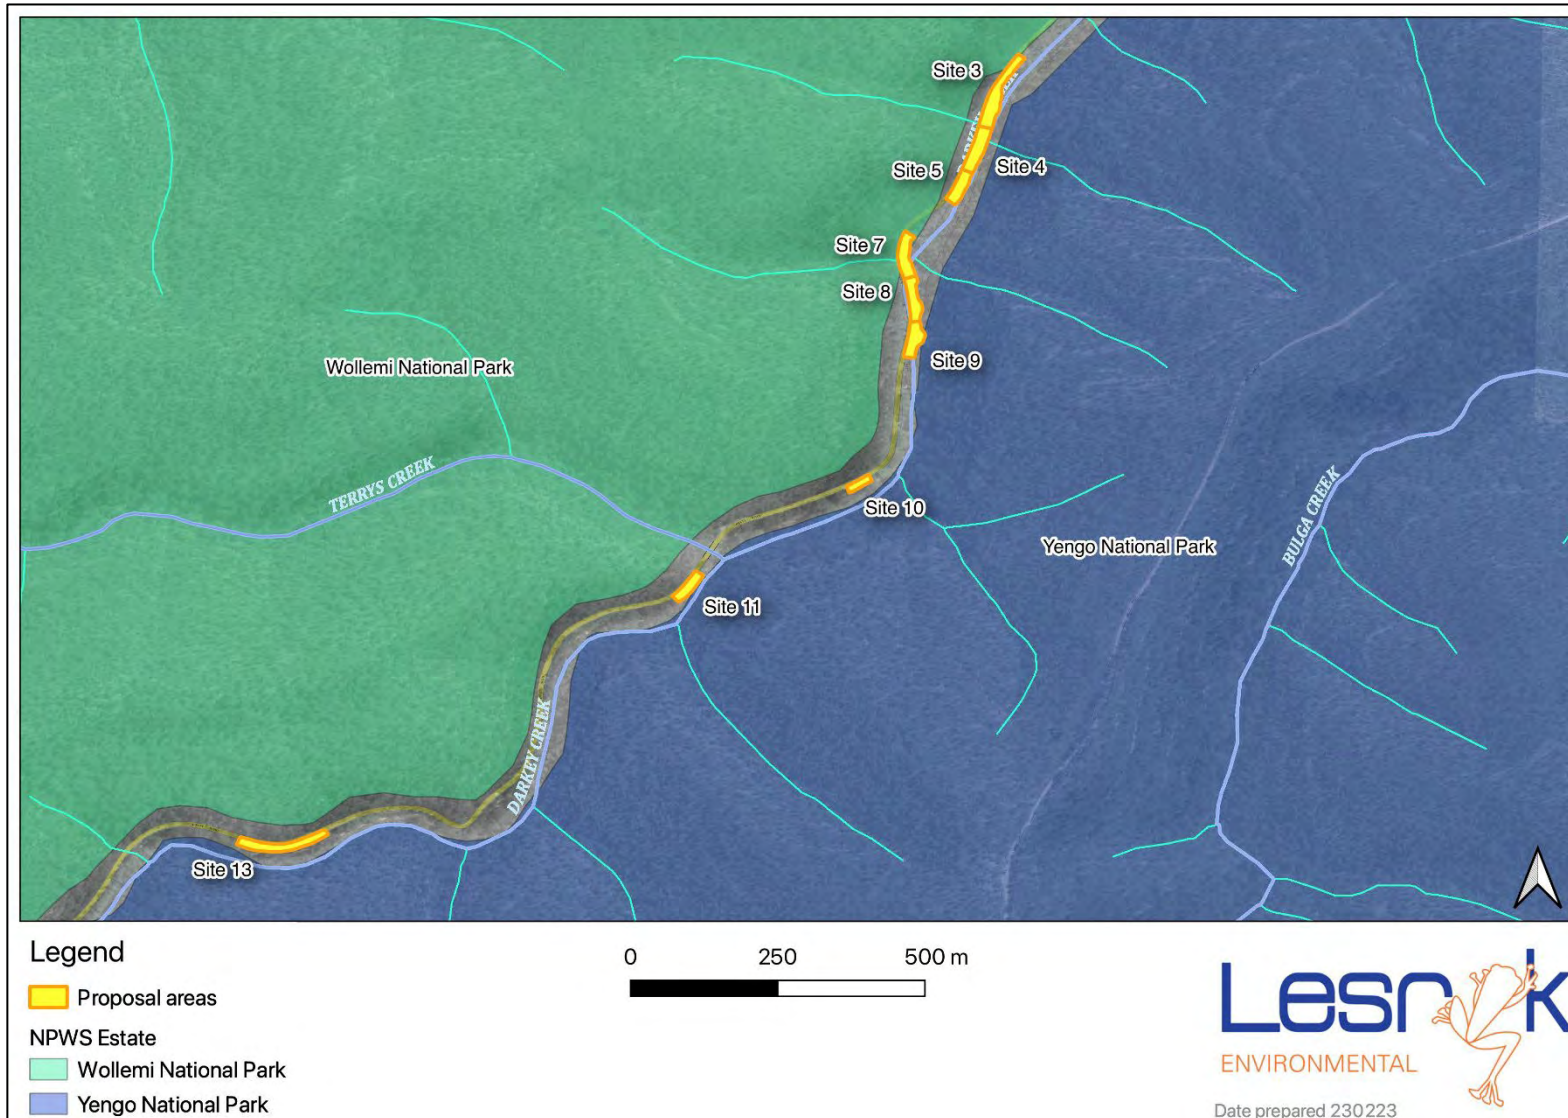
Figure 1-3: Design Plans (extract) for the proposed slope remediation works (TfNSW 2022c).

For reference, extracts of the design plans are provided (Figure 1-3).

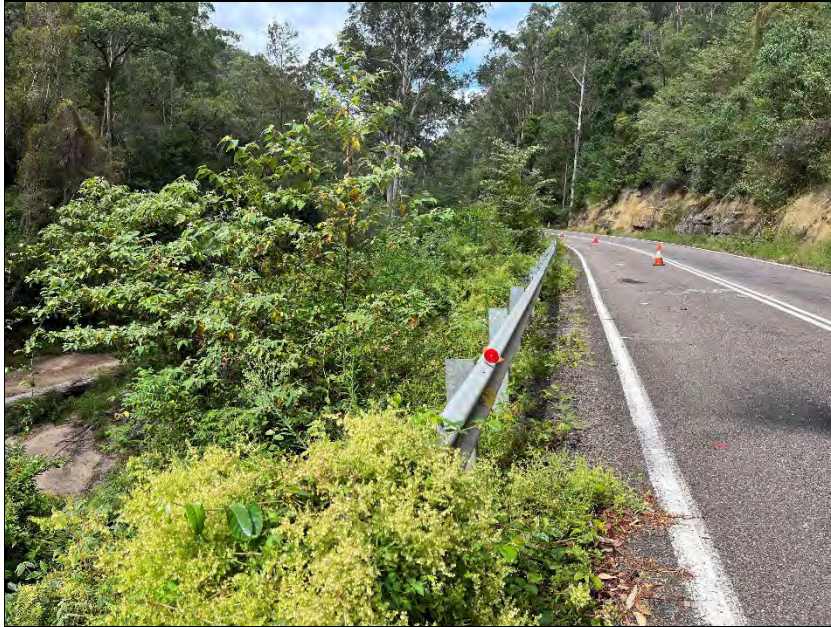
Characteristics of roadside vegetation present at Slope #3.

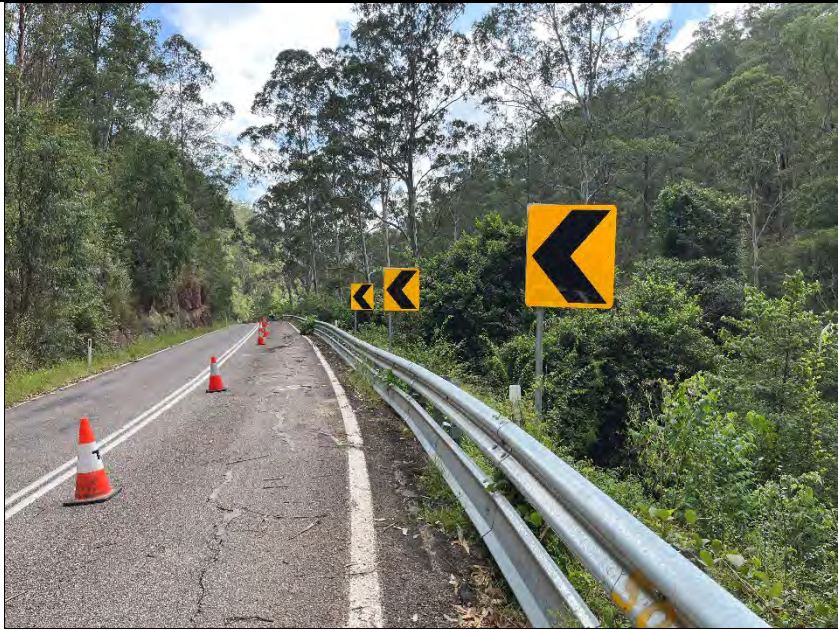
Character of road corridor requiring remediation, with cracks in road surface visible.

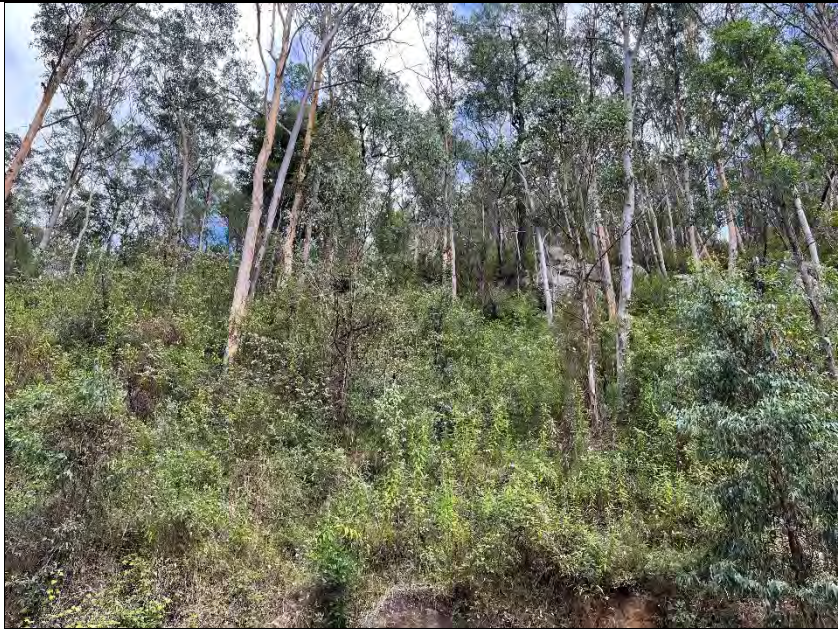
Characteristics of vegetation present upslope of the study area.

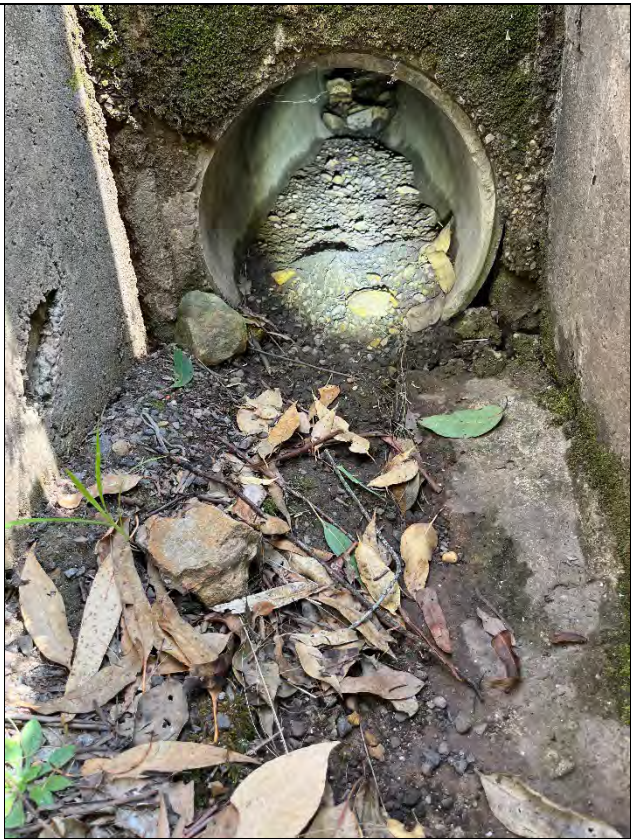
Culverts present at proposal site. No fauna was found in these during the field investigation.

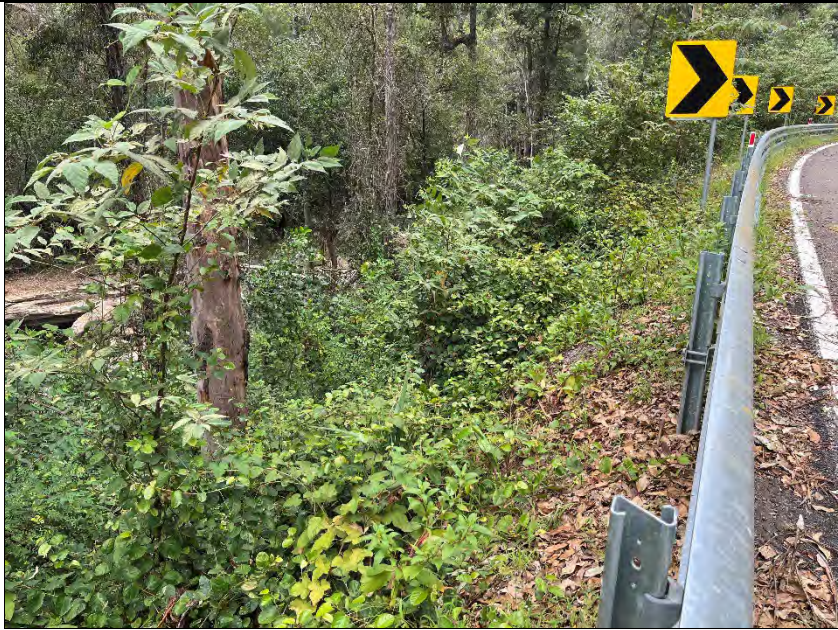
Vegetated character of the downslope remediation areas, where the slope failures have occurred. Note extent of clearing post-fire adjacent to guardrail.

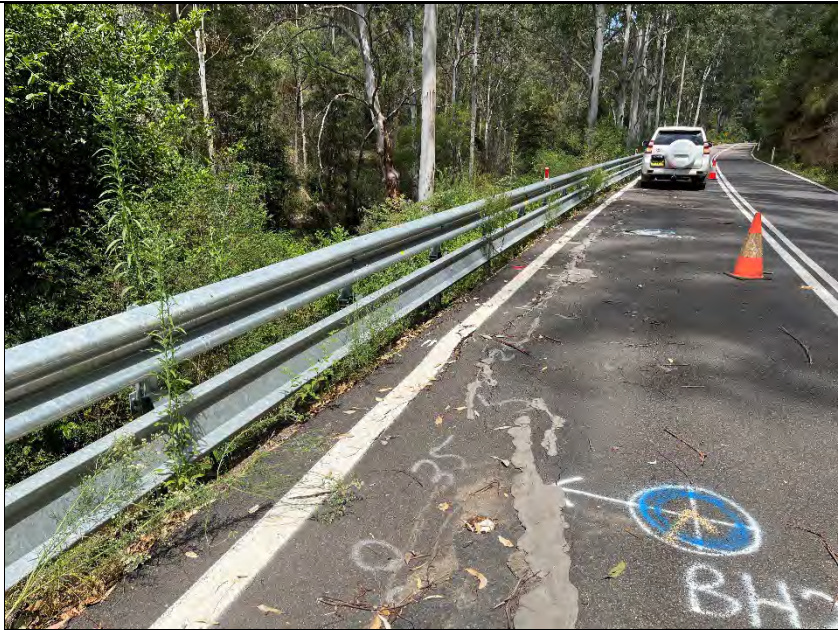
Cracks in road surface caused by slope failure present in study area.

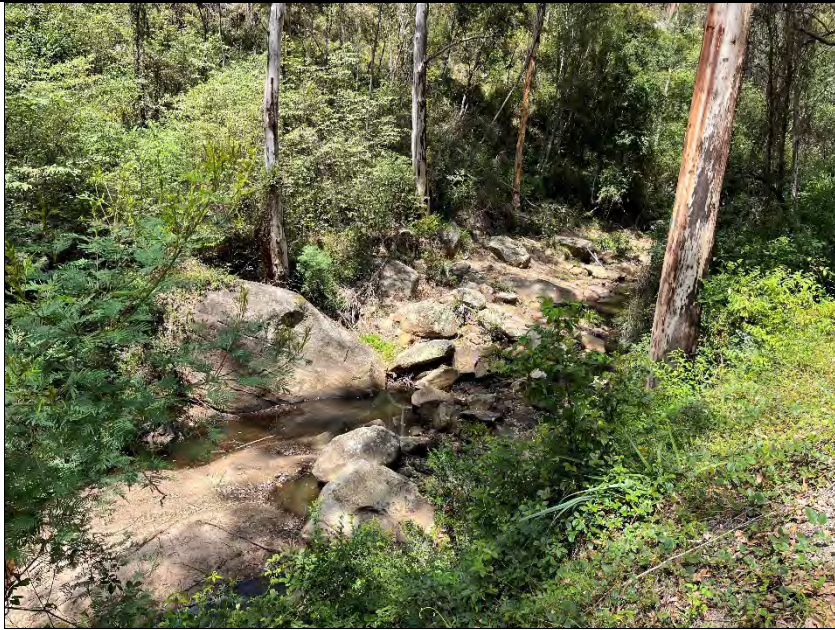
Character of Terrys Creek and surrounding vegetation, approximately 20 m downslope of Putty Road.

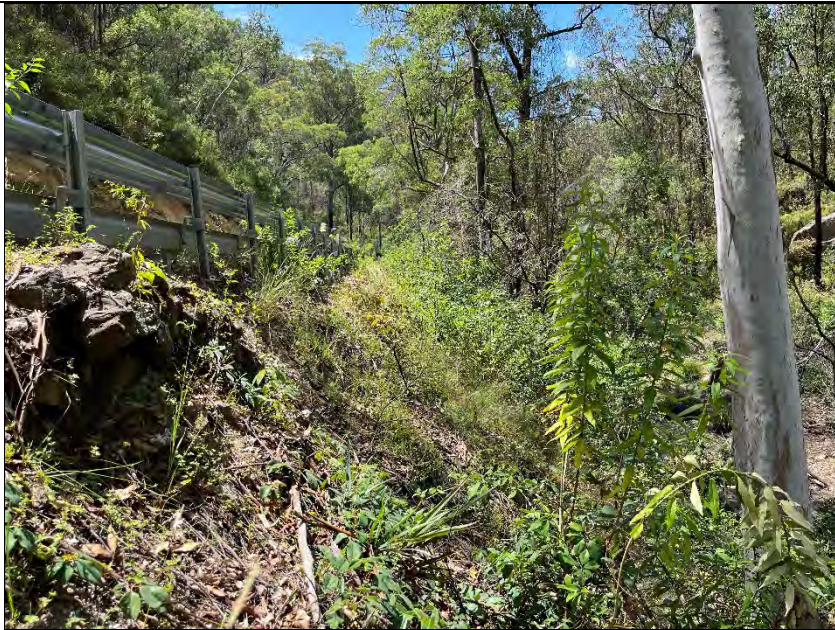
Character of vegetation present and slope at site #13.
